EARLY DEGRADATION OF PV MODULES AND GUARANTY CONDITIONS

M.A. Munoz, M.C. Alonso-García, F. Chenlo
Photovoltaic Laboratory, Renewable Energy, CIEMAT
Avda. Complutense, 22; 28040 Madrid, Spain

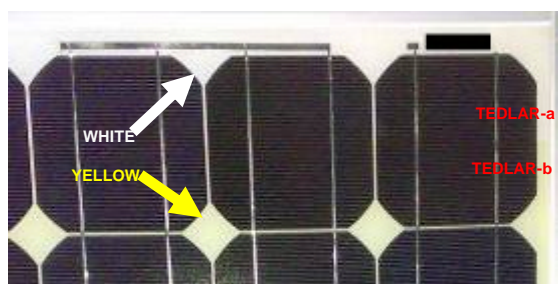
Consist of a tedlar colour change or a colour change in the material in the back side of the module from white to yellow. With the tests performed it can not be asses the influence of this defect in the power losses of the module. Despite this, the yellowing could be a problem if it would start a lack of adherence between the tedlar and the module, causing water penetration inside the module.

In some PV modules, yellowing appear in some areas but not in adjacent areas with a different tedlar of a different origin or characteristics. This should mean that yellowing appears in tedlar instead in the adherent element (usually EVA).

Figure 1 shows an example of how the yellowing effect is due to a change in the colour of the tedlar instead to changes in EVA.

Figure 1.- Yellowing over an area of a PV module.

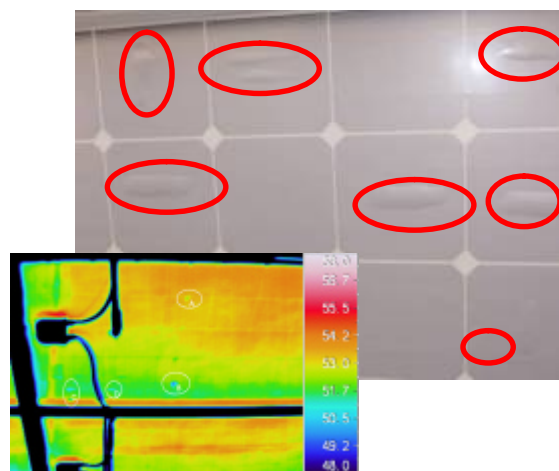
module with the blowing of the areas where this adherence has been lost. These bubbles make more difficult the heat dissipation of the cells in these areas, overheating them with the subsequent reduction of cell lifetime.

On Figure 2 we can see an example of a module with many bubbles in the back side. Usually they appear in the centre of a cell, maybe due to a different adherence of the cell.

Figure 2.- Bubbles in the back side of a PV module.

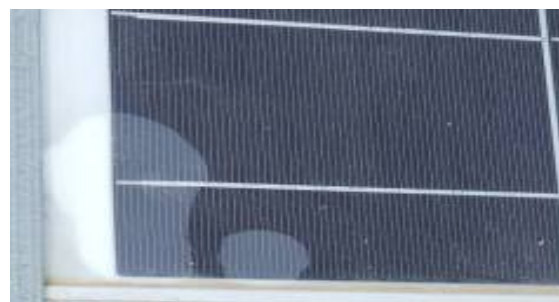
On Figure 3 we can see how bubbles can also appear in the front side of a PV module, between the glass and the silicon cells. In this case it is a detachment between part of the cell and the glass. The influence in the front side of the module is minor in this case, because cells are more rigid than tedlar. Air or gas is again accumulated in the bubbles, probably due to some chemical reaction. Here, apart from heating effects it is added the fact that light incidence in the cell can be reduced.

Figure 3.- Bubbles in the front side of a PV module.

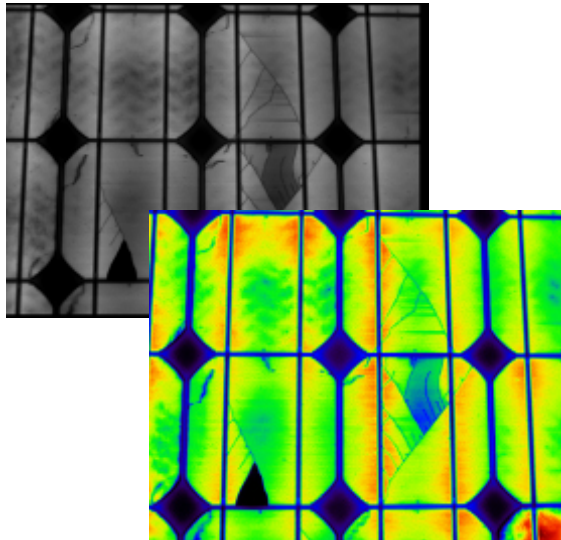
coloured lines are tested by electroluminescence, there is good accordance between these lines and the microcracks observed by EL. Microcracks areas are darker in EL because either they do not produce light emission, or this emission is lower. In some cases the cracks isolate parts of the cell avoiding current generation as we can see in Figure 4.

Figure 4.- Cracks in cells. B&W image and simulated colour image.

The IR characterisation of these modules both in short circuit conditions and in the operation point did not show a particular temperature increase in the damaged areas. Forward bias IR characterisation showed some temperature distributions with the same shape as those found by EL, but temperature differences were rather small (a few degrees, sometimes lower, others higher, than the adjacent areas) making difficult the interpretation of temperature patterns.

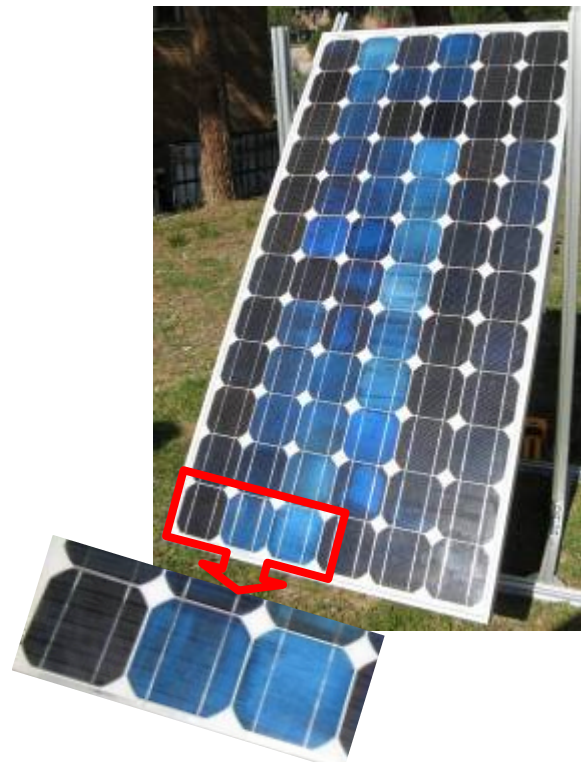
The layer that covers each cell of the module suffers a change that induces a change in the colouring (Figure 5). The antireflection properties may suffer changes as well and in this case the light that achieves the cells may be lower than expected. Nonetheless, this colour change should not cause a decrease in the wavelengths that the cells use, affecting only to visible Light.

IR characterisation of these modules in different conditions did not show any particular effect that could be associated with the changes in the colour of the AR layer.

Figure 5.- Decolouring of cells due to a change in antireflexive coat.

A follow up of the affected modules should be done in order to detect if this defect lead to another that could be severe.

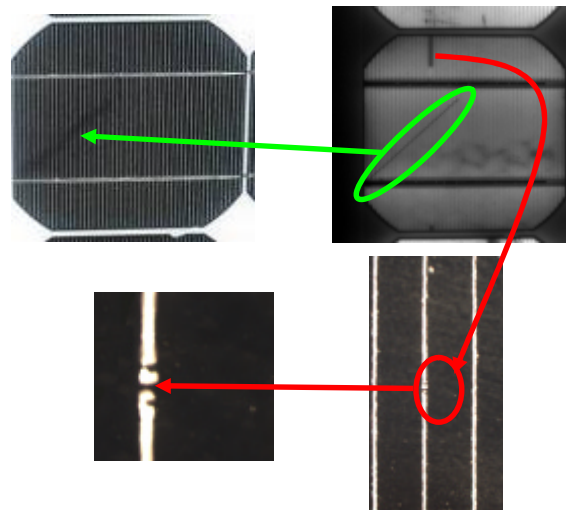
Lines sometimes are indicating a crack in the cell. Probably this crack leads to a chemical reaction or a migration that affects the antireflexive layer and the line appears (Figure 6).

Figure 6.- Two defects detected with EL image. One of them not visible at a sight.

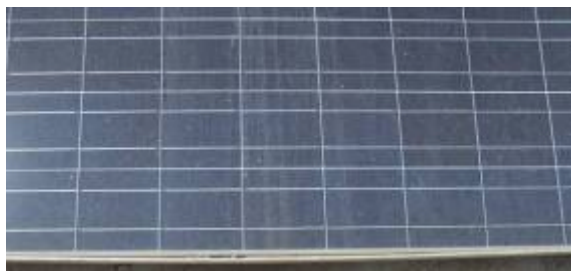
It sometimes appears after the PV module has been installed. It could be due to an incorrect installation where the module supports an excessive weight or because the adherence between the frame and the glass is

not strong enough. We can see an example of this in **Figure 7**.

Figure 7.- Detachment of the frame.

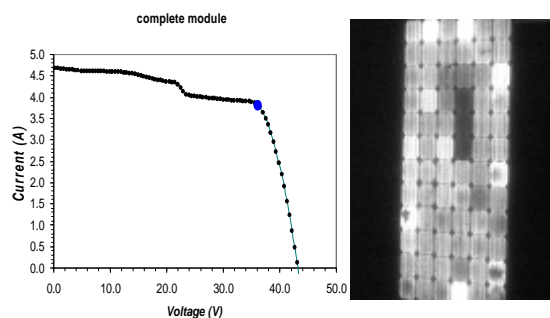
In some cases, a significant degradation is reported. After obtaining a I-V curve of a module where clearly can be seen that a string has bad cells a EL image can be taken to confirm this situation (Figure 8).

Figure 8.- Supposed string with bad cells.

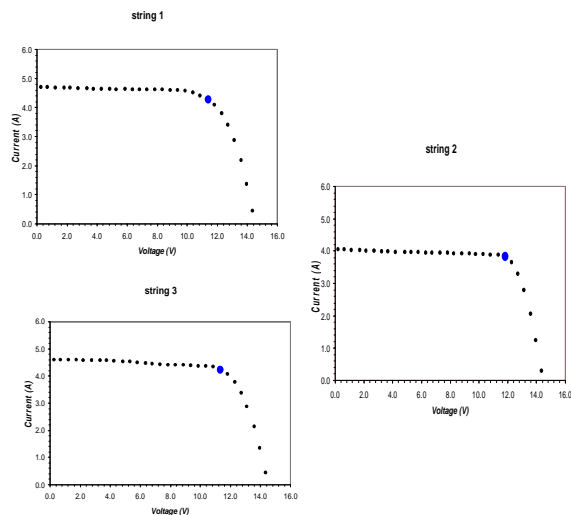
Besides this, an I-V curve analysis string by string can be performed. In this case, the I-V curve can be obtained from the leads of diodes after opening the connections box. Figure 9 shows the same module where the I-V curve was obtained from each string.

Figure 9.- I-V analysis string by string.

The analysis show how central string (string 2) has worse cells than the other ones (current is lower) and it affects the complete module.
